Manhole Inspection Summary

Manhole # S13SS_040MH

Record Plat: **13SS** Node: **040** Status: **Other (Specify in comment)** Insp Date: **7/24/09 9:11 AM**

Location Address: **2700 DUKELAND ST**

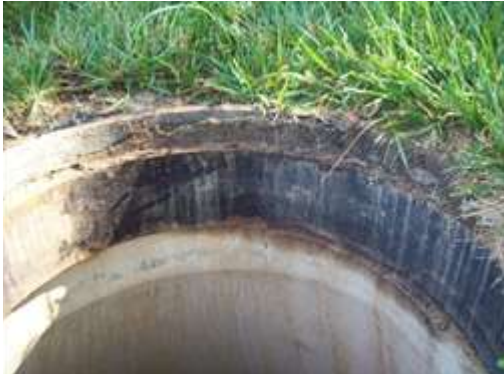
Defect 2

☒ **Leaks**

FRAME LEAKS

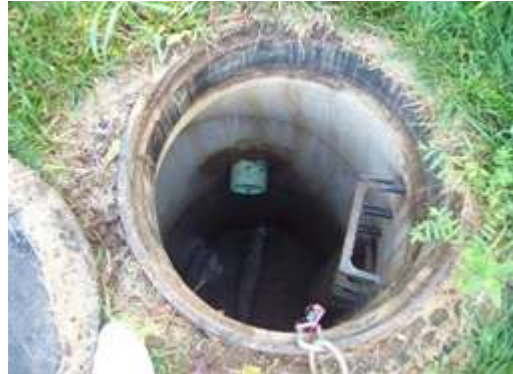
Defect 1

Subject To Ponding: **Sheeting**

SHEETING

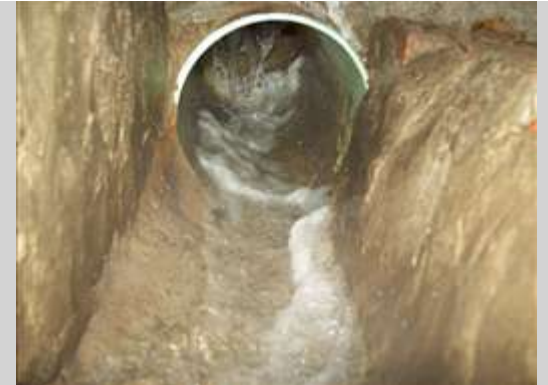
12 O'Clock Outflow

8 in. Circular Gravity Sewer
Pipe Out @ 12 O'Clock

Infiltration: **None**

Pipe Seal Cond: **Sound**

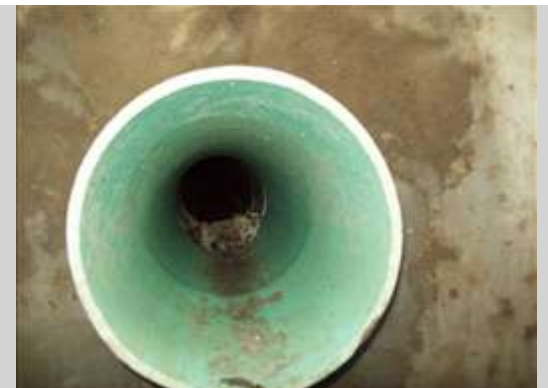
6 O'Clock Inflow

8 in. Circular Gravity Sewer
Pipe In @ 6 O'Clock

Drop In @ 6 O'Clock

Drop: **Inside** Rod Only

Drop Condition: **Open**
